Project: Monroe Library **RFI #:** 31
A/E Project # B-99-01-12 **Date:** 8/21/2012
TO: Lori Stephens - Broadleaf Architecture **Requested Response Date:** 8/21/2012
From: Ed Vaughn - 2G Construction **Trade:** Rough Carpentry
Initiated By: Ed Vaughn - 2G Construction **Subject:** Termite damage @ existing floor joists

Subject JOIST REPAIR - TERMITES DAMAGE

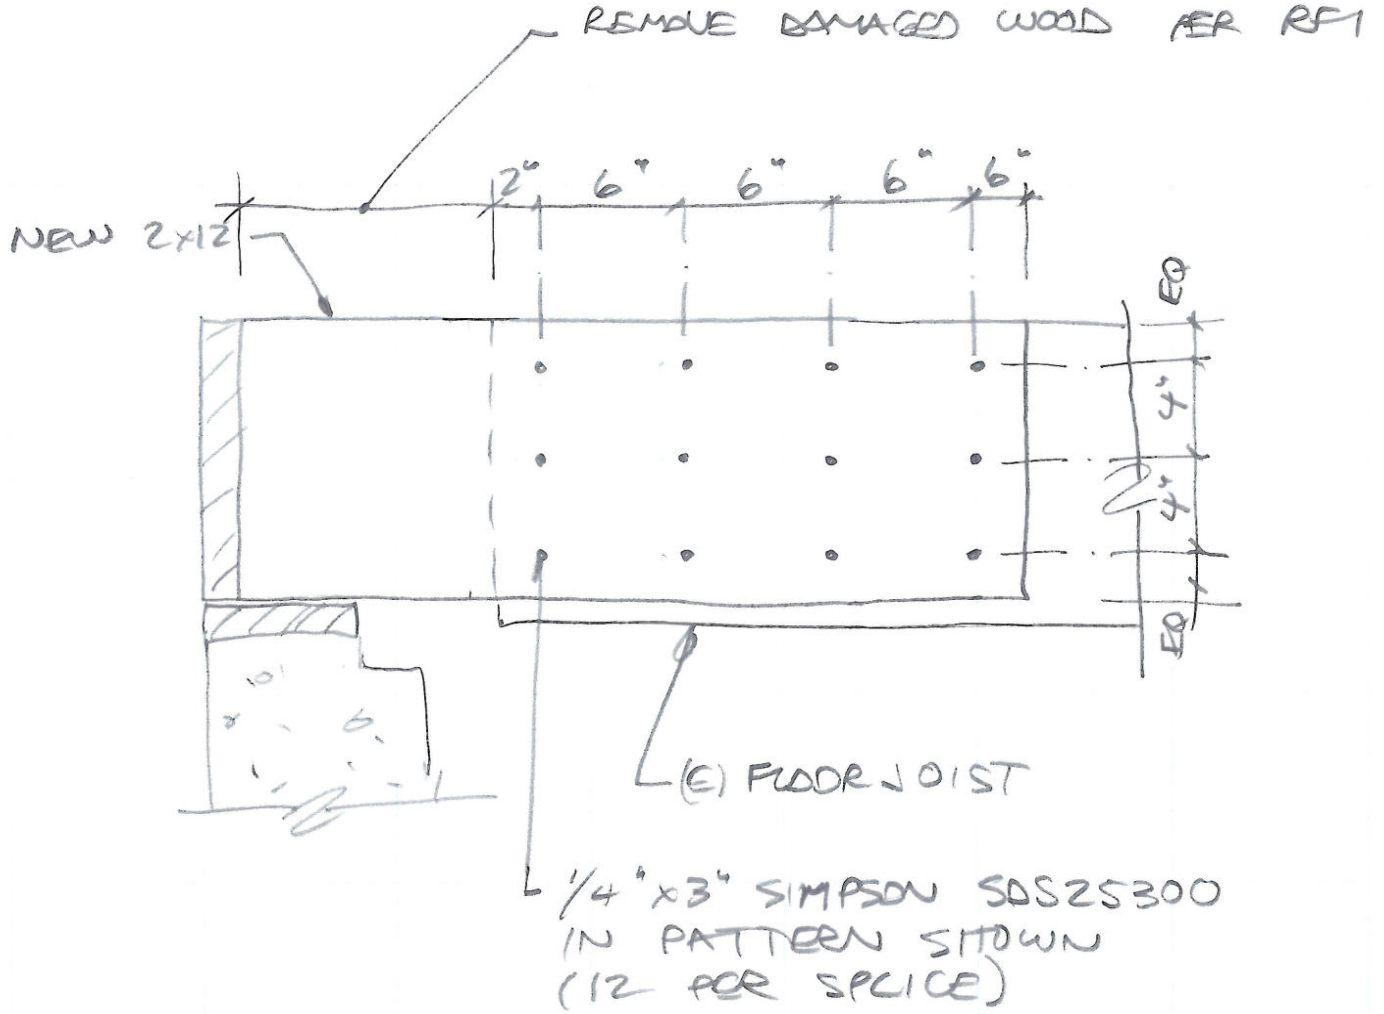
Item #	Description
1	We discovered some termite damage to the existing floor joist in the train depot at the South and North end of the structure. Please provide a detail to laminate new floor joist to the existing that will extend to the South rim joist. See attached pictures. Cut out portion of joist will be the following: 1 @ 3", 1@ 8 1/2", 2 @ 15", 1 @ 18", & 1 @ 42". The East & West rim joist have an existing splice @ 8' and sit entirely on mud sill. The first existing beam is 8' back from South rim joist.

Item #	Response:
1	Shore joists and remove damaged material. Splice new 2x12's as per enclosed detail SK-1 with Simpson SDS25300 screws. Install/splice rim joist per nail lam notes in drawings.
